OBSERVATIONS ON AN AILERON-FLUTTER INSTABILITY ENCOUNTERED  
ON A 45° SWEEP-BACK WING IN TRANSONIC AND SUPERSONIC FLIGHT

Marvin Pitkin, William N. Gardner  
and Howard J. Curfman, Jr.

Langley Memorial Aeronautical Laboratory  
Langley Field, Va.

April 11, 1947

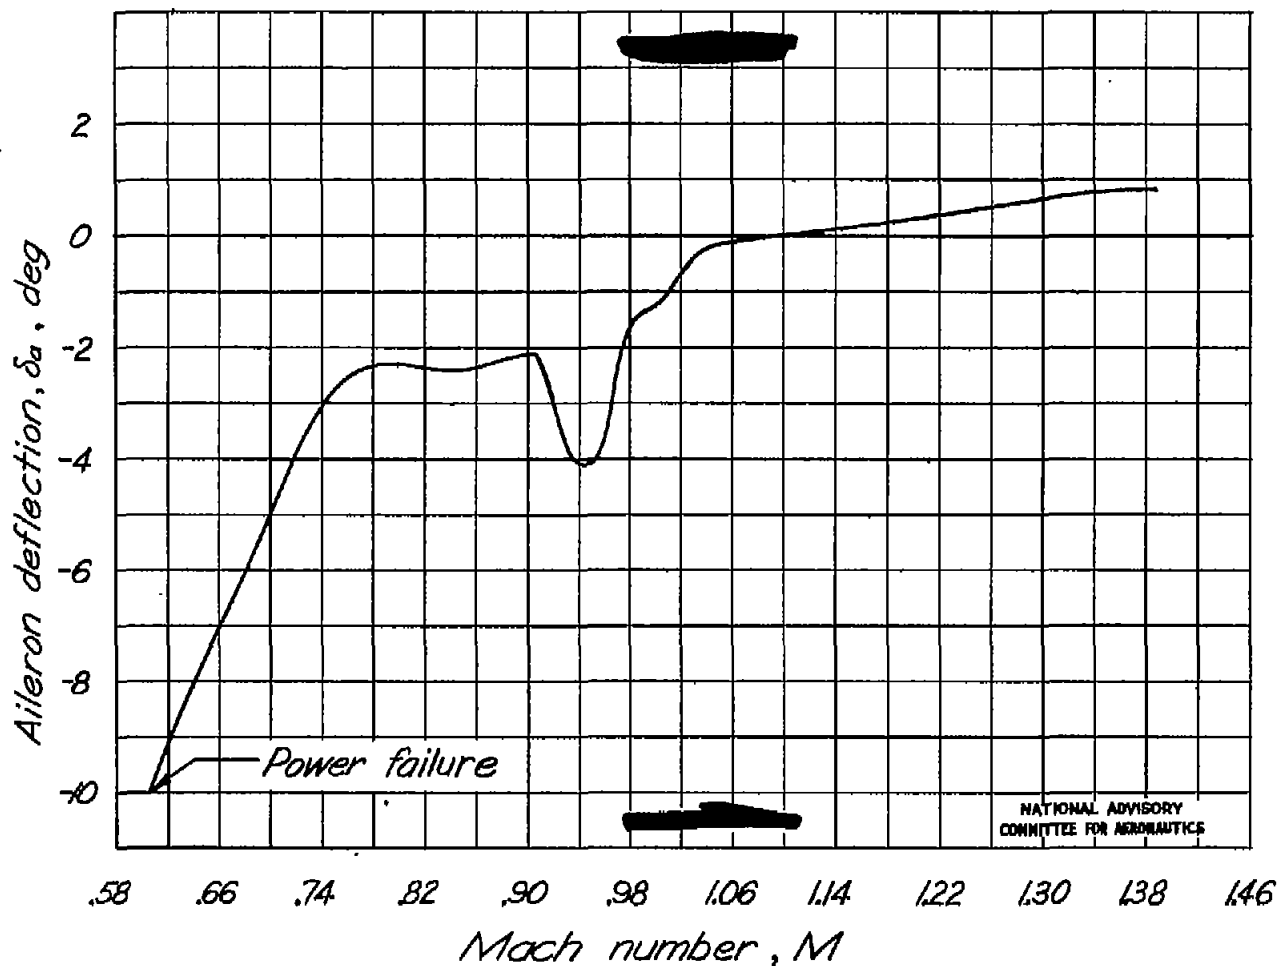
(b) Aileron deflection - Mach number.  
Figure 8.- Concluded.

The data presented in figure 8(b) show that when power failed ( $M = 0.6$  approx.) the control was at full deflection and was slightly underbalanced in this deflection range as shown by its drift back toward neutral position. At higher subsonic velocities ( $M = 0.8$  to  $0.9$ ) the control trimmed at a constant deflection of approximately  $-2.3^\circ$  indicating thereby that the control was overbalanced at smaller deflections. The possibility that the  $-2.3^\circ$  deflection is the result of out-of-trim moments has been considered; however information to be presented later herein discounts this possibility. The tendency of the control to overbalance at small deflections is characteristic of beveled-edged controls

At Mach numbers between 0.90 and 0.95 the floating angle of the aileron increased abruptly indicating overbalance over a larger deflection range. A further increase in velocity reversed this effect and the control quickly returned to its neutral position remaining there until the peak Mach number of 1.395 was reached.

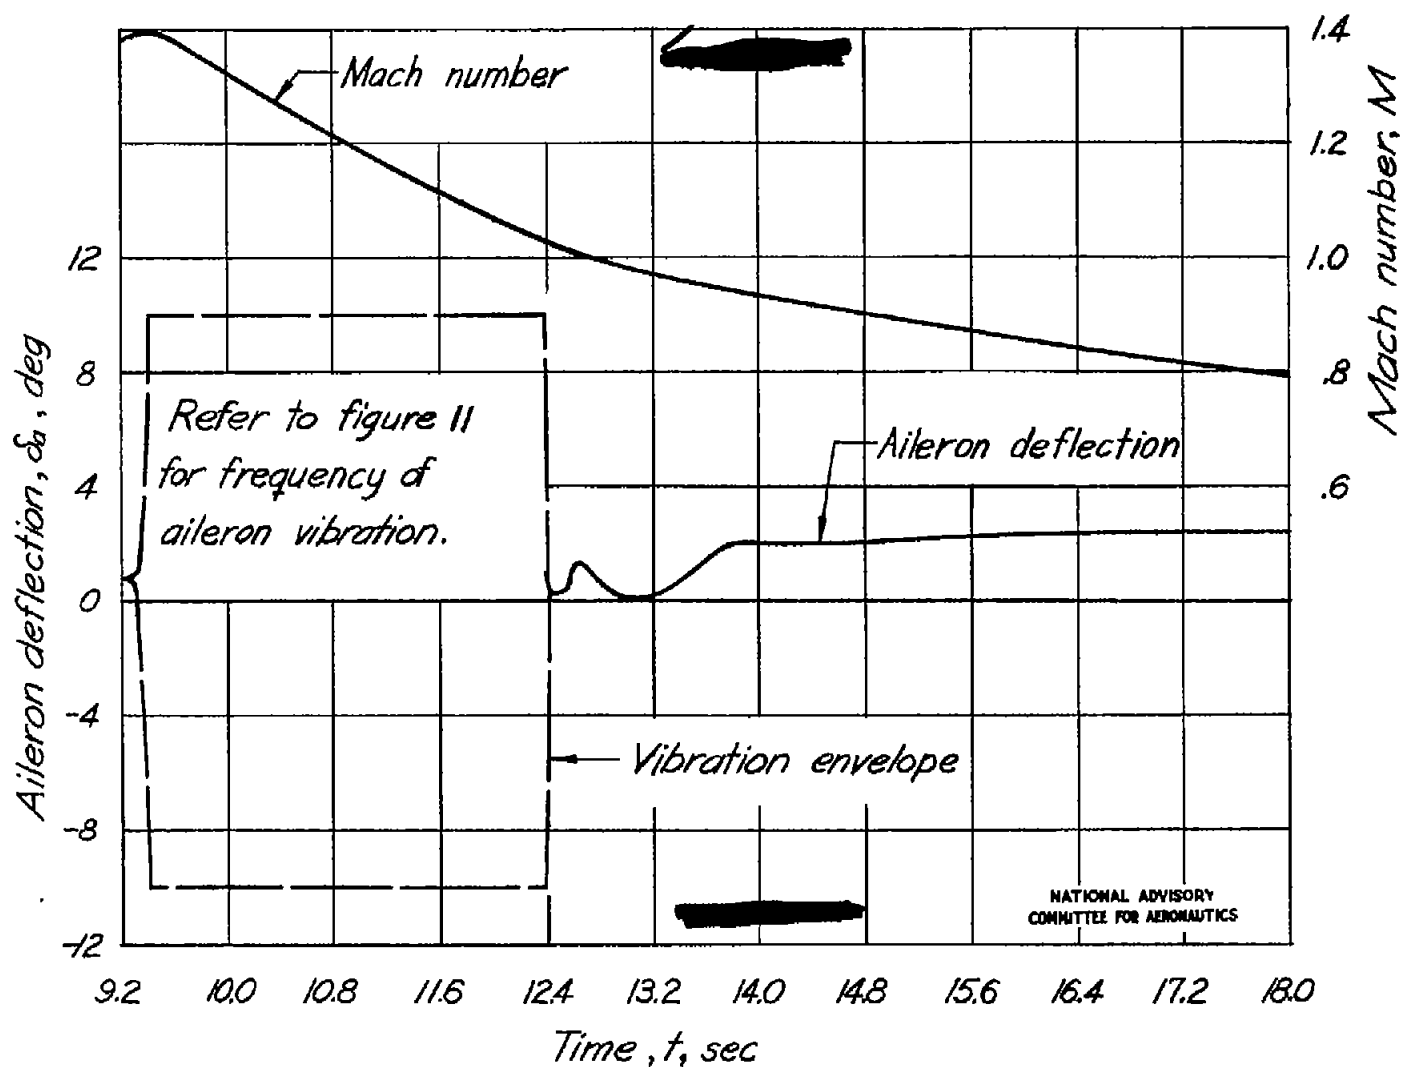
(a) Aileron deflection and Mach number against time.  
 Figure 9. - Aileron characteristics in coasting flight.

After the sustaining rocket ceased firing and precisely at the time the forward acceleration passed through zero, a violent high-frequency oscillation occurred on the aileron and wing. The failure of the ailerons to vibrate during the accelerated portion of the flight probably can be attributed to the restraining forces in the servomechanisms which were mounted in such a manner that the large forward accelerations of 6g to 8g could increase their friction considerably. Once the oscillation occurred, however, the friction forces caused by the small decelerations in coasting flight apparently had little influence upon the aileron behavior.

Figure 9(a) shows a time history of the aileron behavior in coasting flight, and in figure 9(b) these data are rearranged to show the variation of aileron deflection with Mach number.

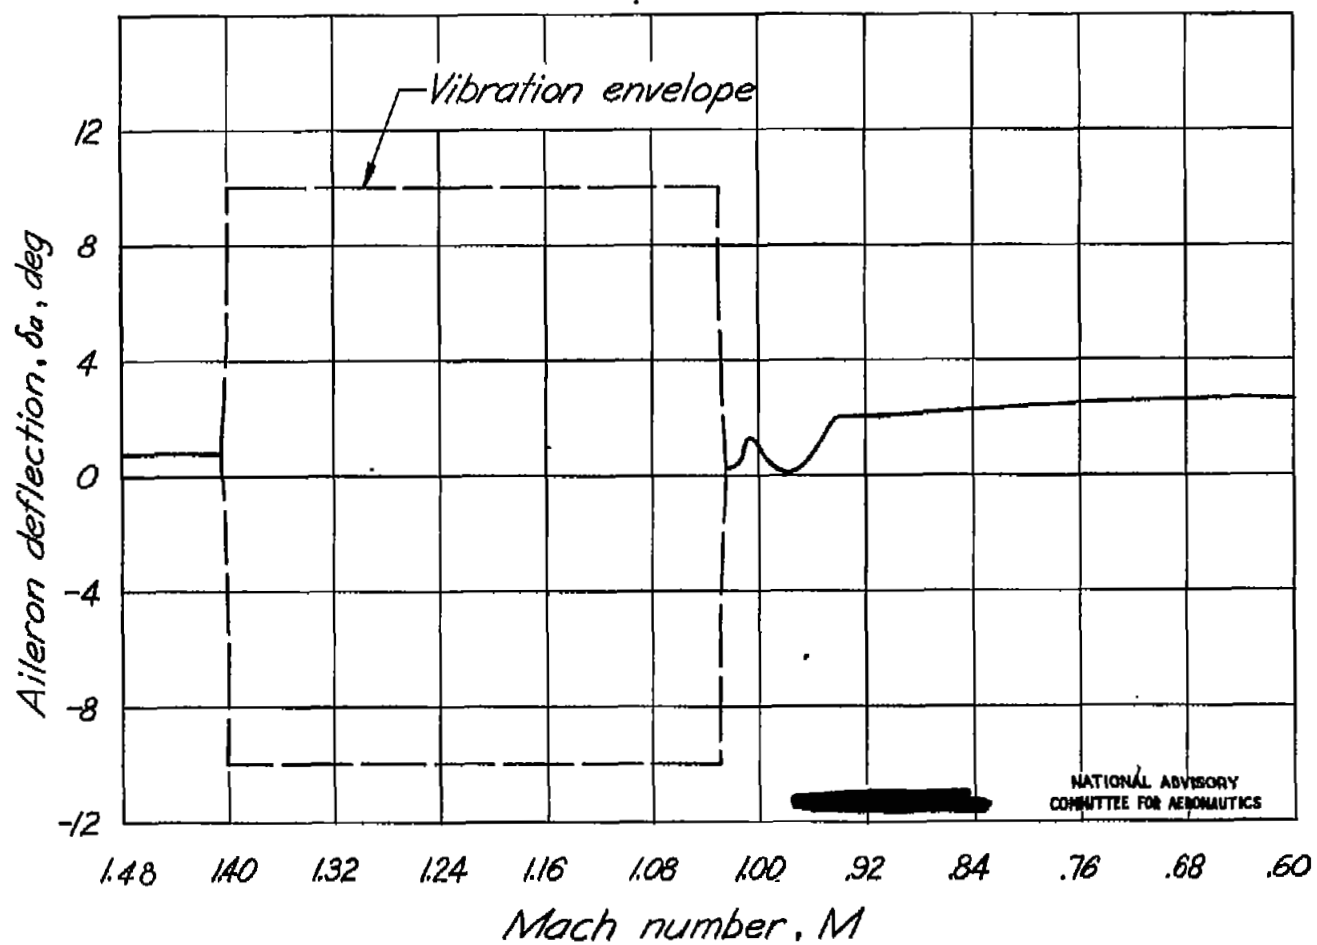
(b) Aileron deflection - Mach number.  
Figure 9.- Concluded.

The data presented in figure 9(b) show that the aileron oscillated with an amplitude of full  $\pm 10^\circ$  deflection over the entire supersonic range of velocities. As the velocity fell below a value corresponding to a Mach number of 1.03, erratic aileron behavior was observed in the transonic region, and at subsonic speeds the aileron again floated at a small deflection of  $2.4^\circ$ . This deflection is approximately equal to the trim deflection noted at subsonic speeds in accelerated flight; however the deflection is now positive rather than negative and therefore substantiates the idea that the deflection indicates overbalance of the control and not merely an out-of-trim position.

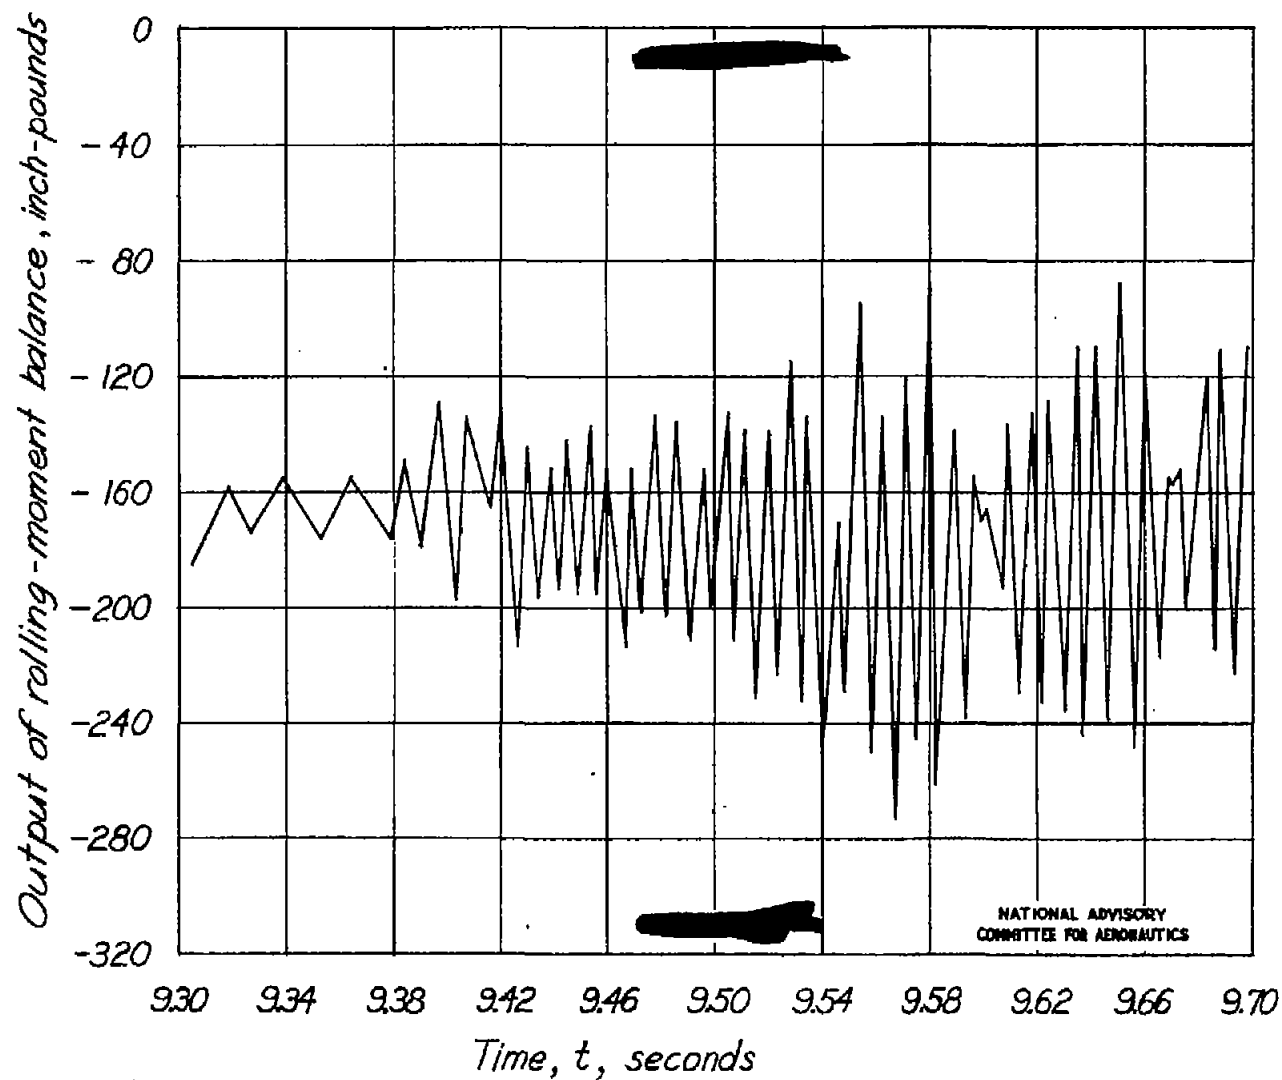
(a) Start of vibration period.  
Figure 10. - Time history of rolling-moment balance vibration.

A high-frequency wing oscillation accompanied the aileron oscillation at all times. The characteristics of this wing oscillation as evidenced by rolling-moment data at the start and at the end of the vibration period are presented in figures 10(a) and 10(b), respectively. It is believed that the amplitude of the wing vibration as shown by these data represents approximately 50 percent of the actual magnitude. The exact percentage is not definitely known however because a frequency response test of the recording instrument was not made at the time of the flight but at some time afterwards, and the instrument characteristics may be subject to change over a period of time. The modulation of the rolling-moment record, prevalent except for the last half second of the vibration period, is believed to be due to deficiencies in the recording equipment when operating at frequencies outside of its design range.

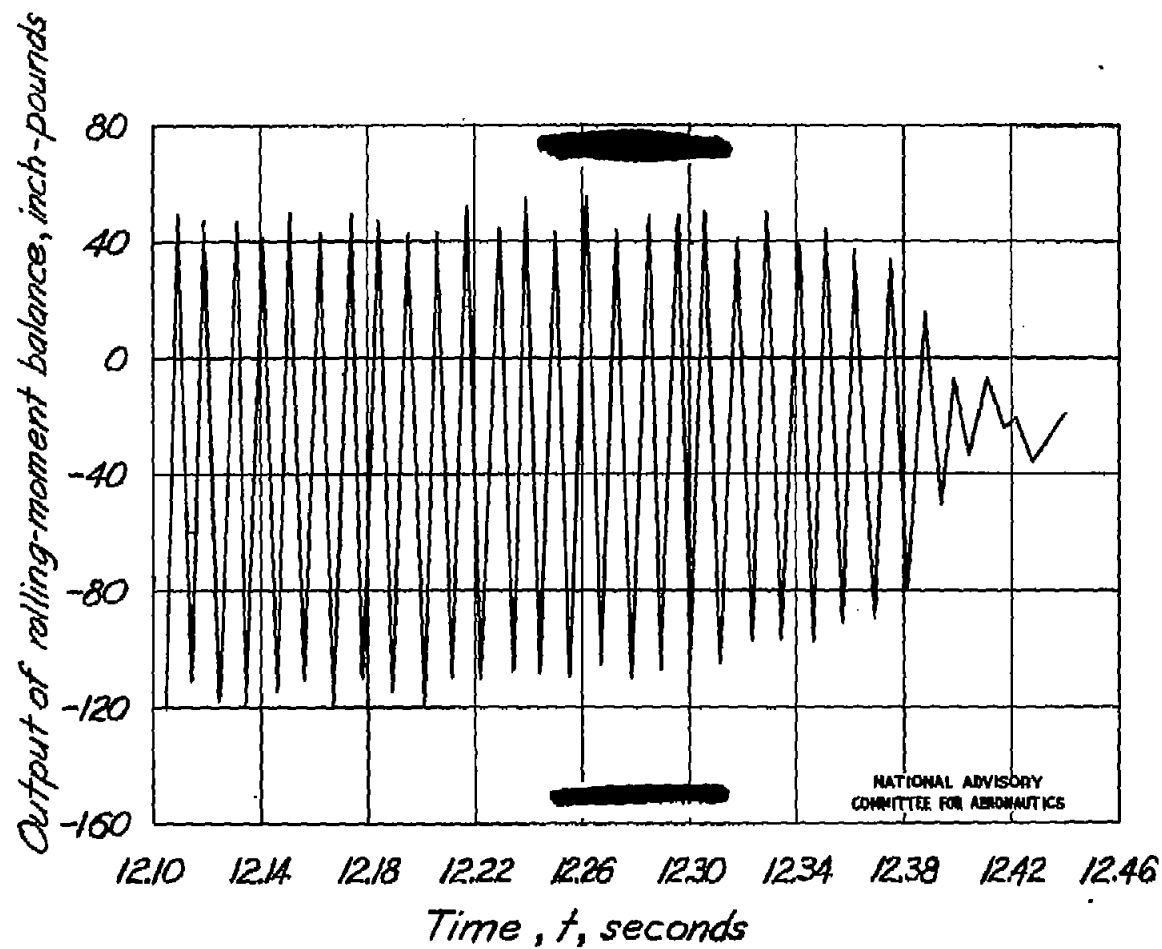
(b) End of vibration period.

The data in figure 10(b) show that both the wing and aileron oscillations stop at approximately the same Mach number (1.03) at which the ailerons regained control on the RM-1 flight reported in reference 1. As the velocity was reduced past the velocity corresponding to this value, the aileron did not show the large degree of overbalance noted at near-critical speeds in accelerated flight but instead appeared to regain its subsonic characteristics without appreciable transition. It is possible that the violent aileron oscillation in the supersonic region may have damaged the control-position indicator causing faulty readings. Another more likely explanation may be that shock conditions on the wing do not disappear in the same manner in which they are formed. It may be that the wing shock waves vanish abruptly as the velocity is decreased through the critical speed rather than by a gradual process of weakening intensity. Such procedure would explain the aileron behavior of the RM-1 model at transonic and subsonic velocities in coasting flight.

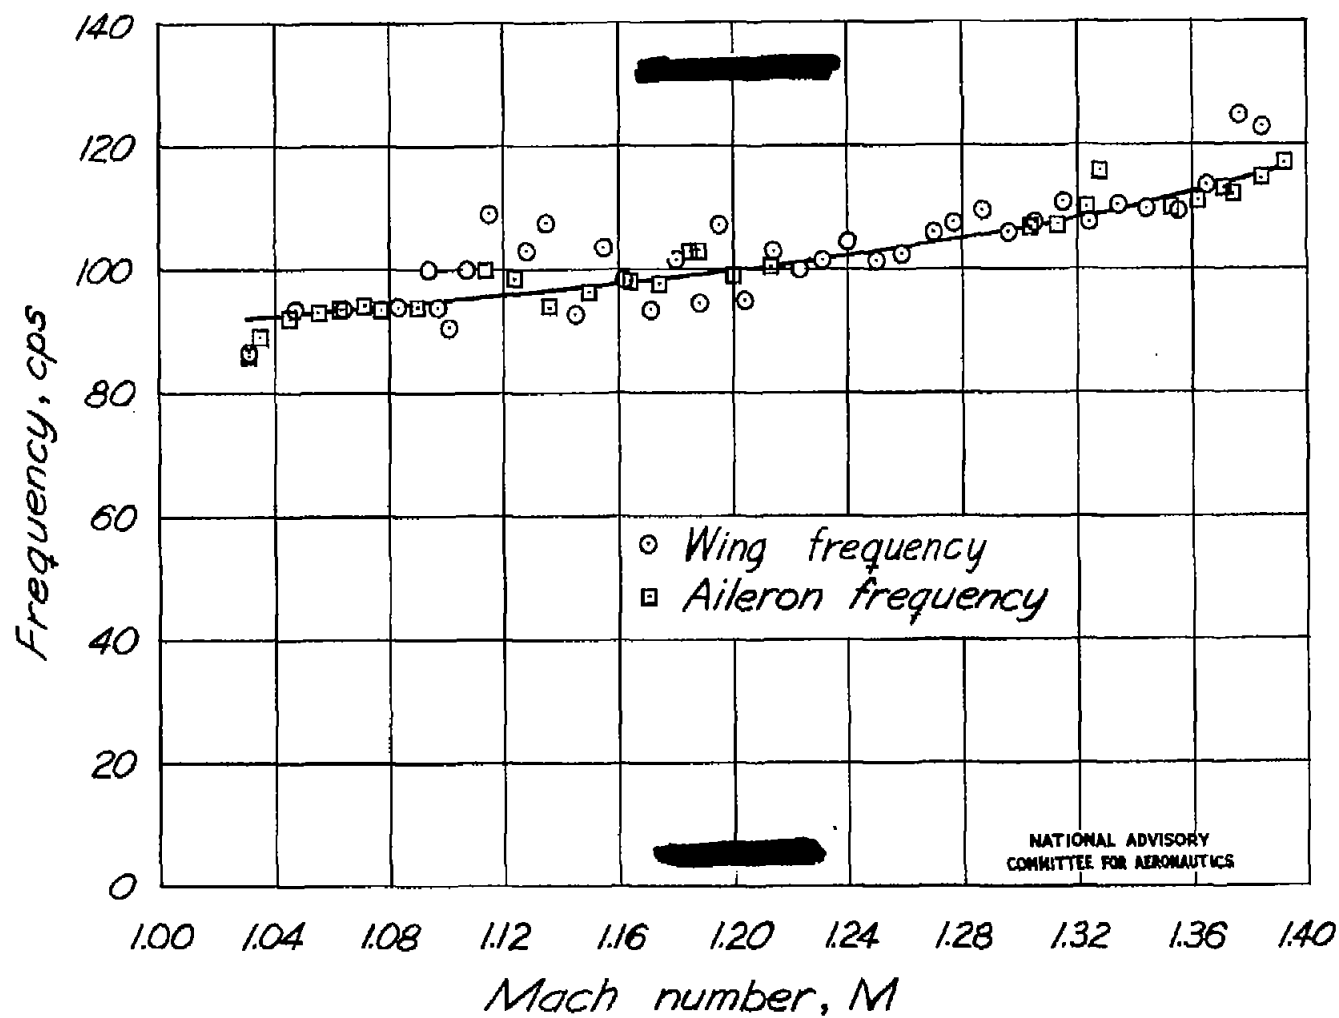
Figure 11.-Variation of wing and aileron vibration frequencies with Mach number.

The frequency characteristics of the wing and aileron vibration are shown plotted against Mach number in figure 11. These data show the wing and ailerons vibrated at the same frequency for any given Mach number and that the frequency of the wing and aileron oscillations increased with increase of Mach number.

The flutter speed of swept-back wings of the type used on the RM-1 cannot be calculated at present. Vibration tests were therefore made on a wing rolling-moment balance setup identical to that used on the model reported herein. These tests showed that the first symmetrical bending frequency was 21 cycles per second with the node at the root chord and that the symmetrical torsion frequency was 75 cycles per second with the node line approximately parallel to the leading edge and at a distance of 48 percent of the wing chord behind it. In the simplest type of classical wing flutter, the flutter frequency would be expected to lie between those of first bending and first torsion frequencies. However, the frequencies of the vibrations recorded in the flight tests (90 to 120 cycles per second) were considerably higher than

the wing structure frequencies measured. It is probable therefore that the flight oscillations did not represent a classical flutter condition but rather were associated with the phenomenon known as "aileron buzz" or aileron compressibility flutter hitherto encountered only on straight wing-aileron combinations of nonsymmetrical airfoil section, at supercritical speeds. Flight tests of a Bell P-63A-6 airplane reported in reference 4 and wind-tunnel tests of a modern high-speed-airplane wing made in the Ames 16-foot high-speed tunnel show aileron and wing oscillations at high speed similar to those observed in the subject test. It is believed that aileron compressibility flutter is associated with a coupling of the variations of the relative intensities of the upper-surface and lower-surface shock waves with aileron motion. The condition might be considered to be a flutter condition requiring only one degree of freedom, that is, aileron rotation about its hinge line. The wing oscillation is believed to be the result of flow and load changes induced by the aileron and in the case of the RM-1 model was probably amplified in intensity by the flexibility of the wing and rolling-moment balance system.
